FINAL
Hazardous Building
Materials Assessment

North Stormont Public School
57 Cockburn Street, Berwick,
Ontario

March 9, 2023

Pinchin File: 302783.058

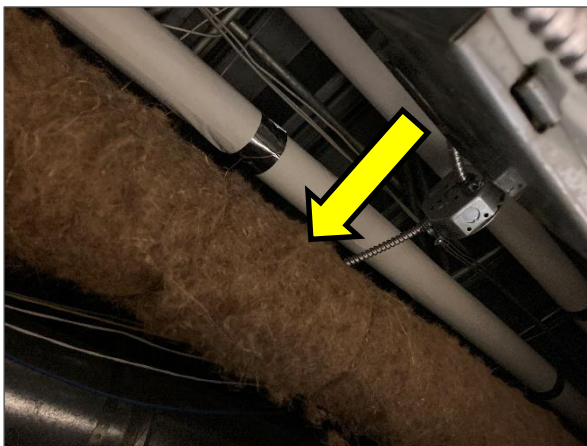
Horsehair insulation present on rain water leaders in the Central Corridor (Loc.3) does not contain asbestos (previous Pinchin samples S0004A-C).

Non-asbestos horsehair insulation.

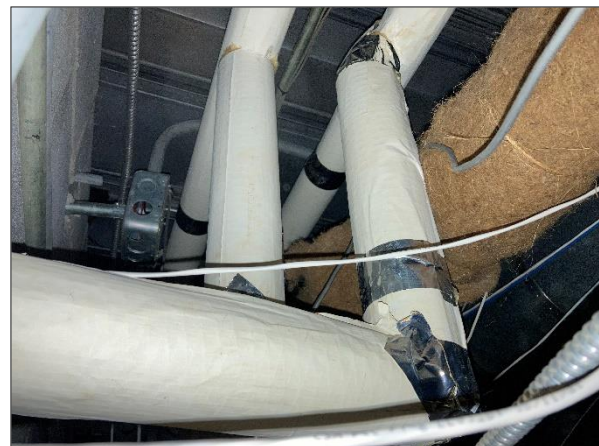
Pipes insulated with non-asbestos fibreglass.

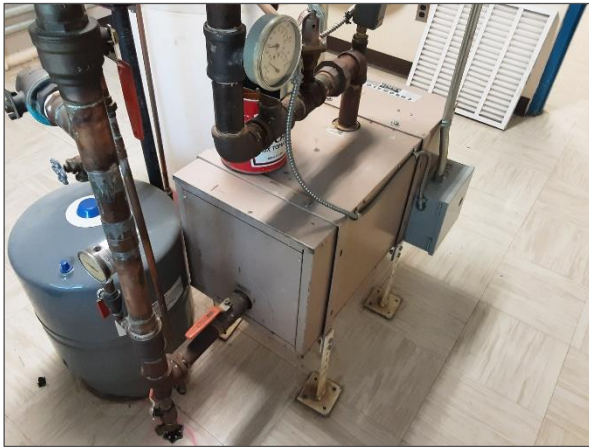
Furnace insulated with non-asbestos fibreglass.

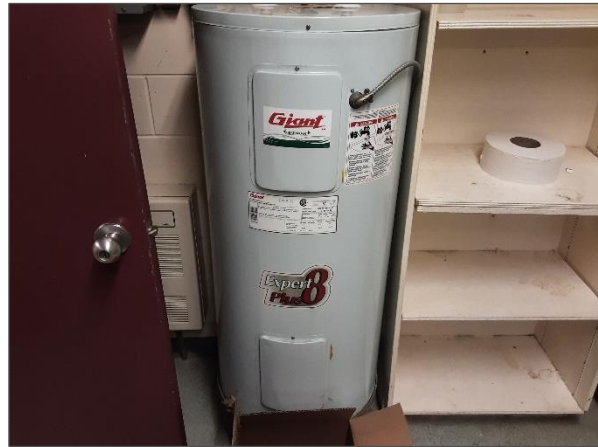
Hot water tank insulated with non-asbestos fibreglass.

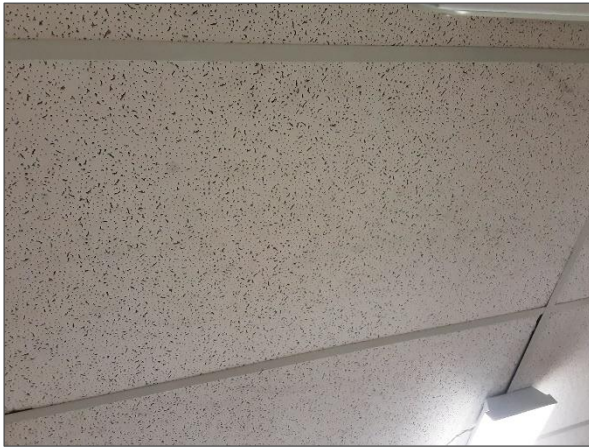
Non-asbestos lay-in ceiling tiles with small pinholes, small fissures.

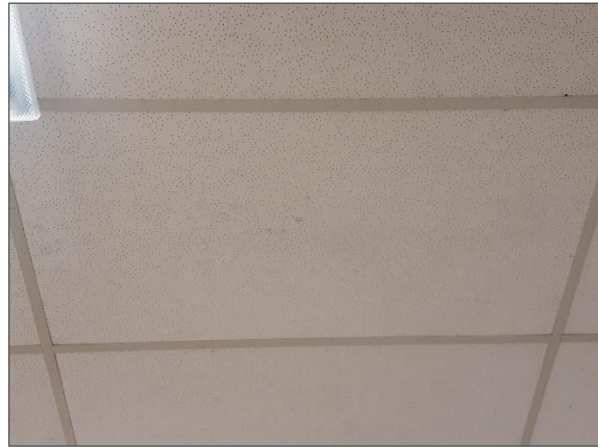
Non-asbestos lay-in ceiling tiles with small and medium pinholes.

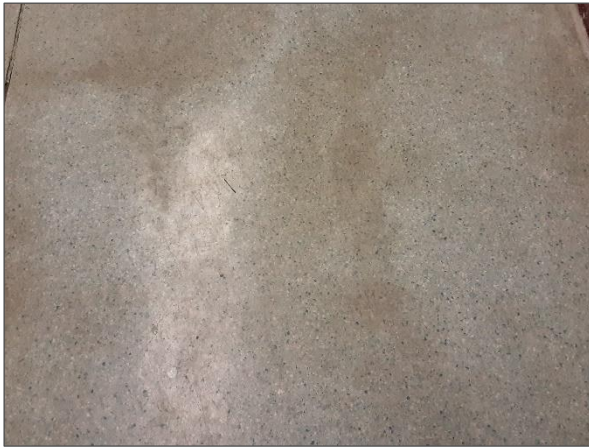
Non-asbestos vinyl sheet flooring with blue and white specks.

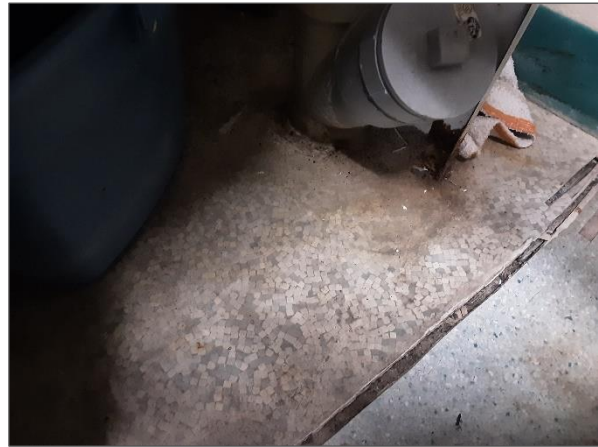
Non-asbestos vinyl sheet flooring with grey squares.

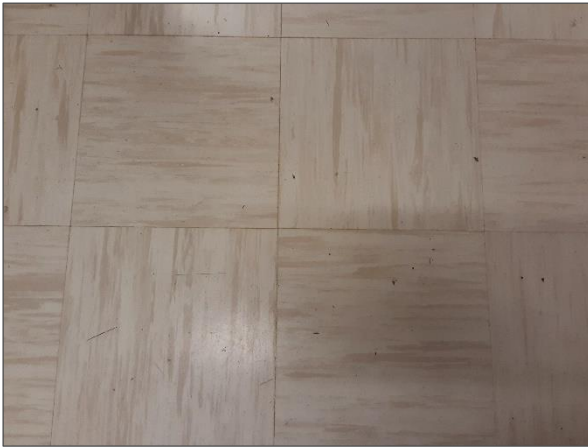
Non-asbestos vinyl floor tiles with large white and beige streaks.

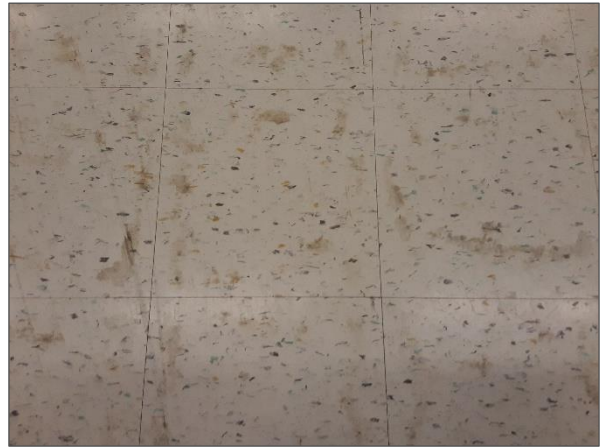
Non-asbestos vinyl floor tiles with large white and grey streaks.

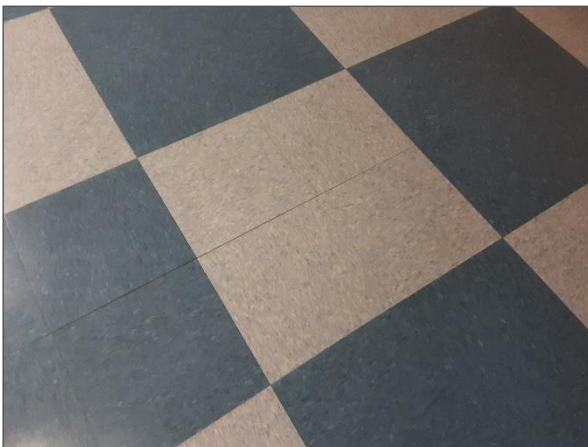
Non-asbestos blue and light blue vinyl floor tiles with fleck.

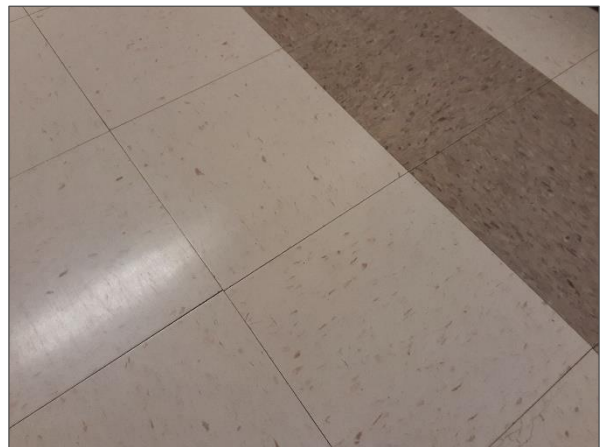
Non-asbestos grey and beige vinyl floor tiles with fleck.

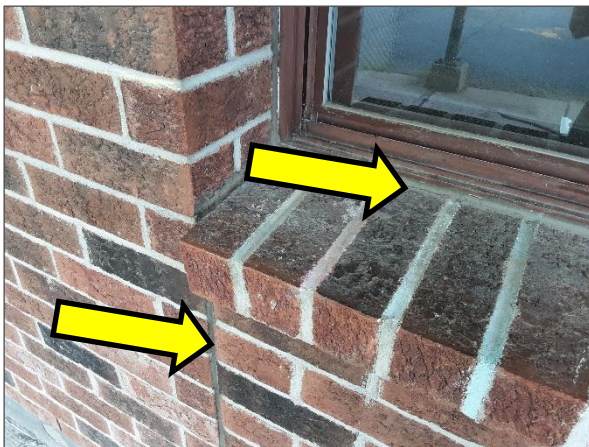
Non-asbestos light brown caulking.

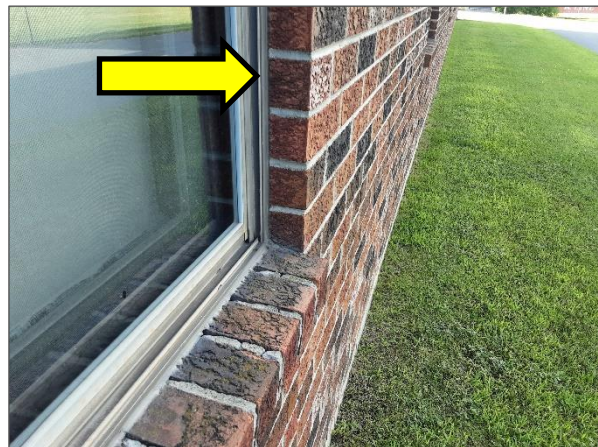
Non-asbestos brown caulking.

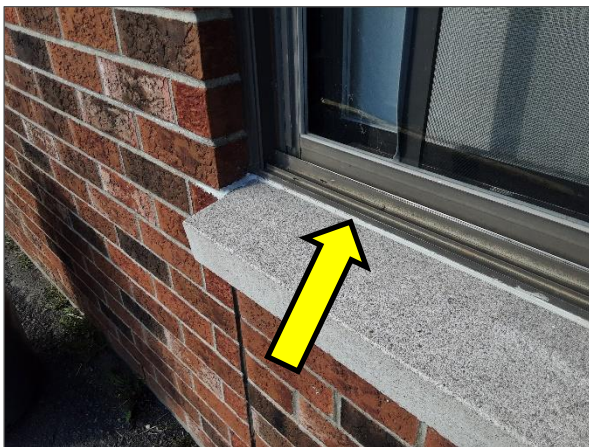
Non-asbestos light grey caulking.

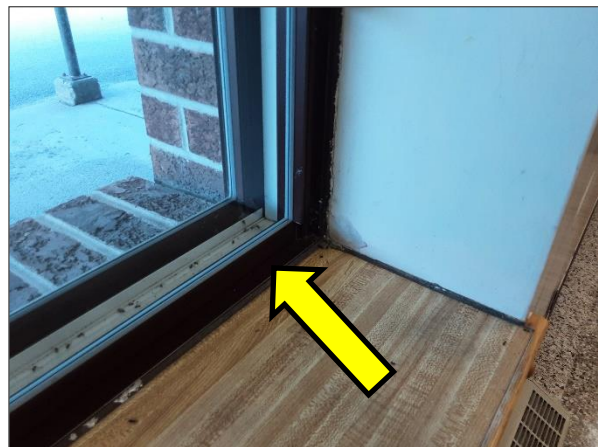
- Hard brown window caulking
- All asbestos-containing materials were observed to be in good condition

Asbestos-containing hard brown caulking.

Prepare an Asbestos Management Program (AMP). The AMP should address and document; written work practices, worker training, notifications, policies and responsibilities.

Perform a re-assessment of asbestos-containing materials (ACM) on an annual basis.

Remove ACM prior to alteration or maintenance work if ACM may be disturbed by the work. Follow appropriate asbestos precautions for the classification of work being performed.

Asbestos-containing materials must be disposed of at a landfill approved to accept asbestos waste.

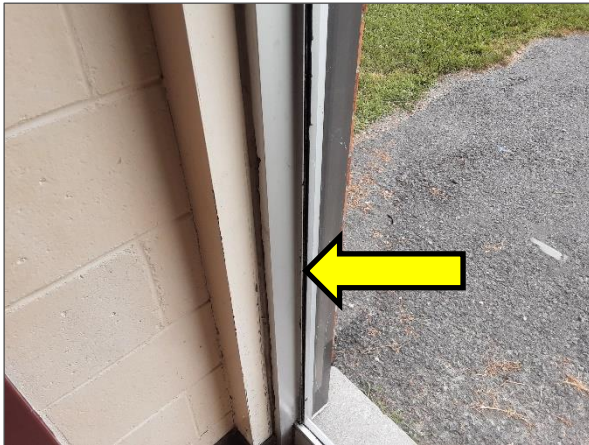
Non-asbestos black butyl sealant.

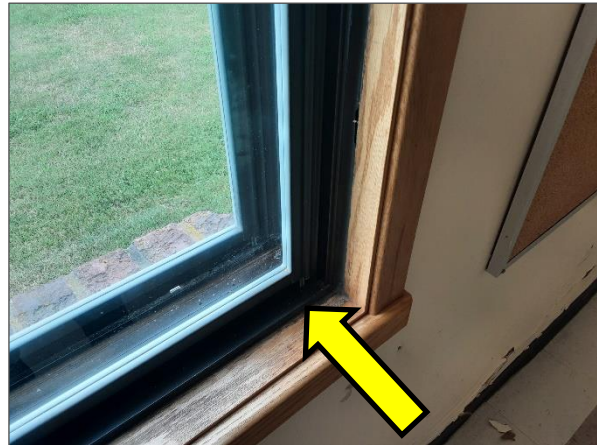
Non-asbestos dark brown caulking.

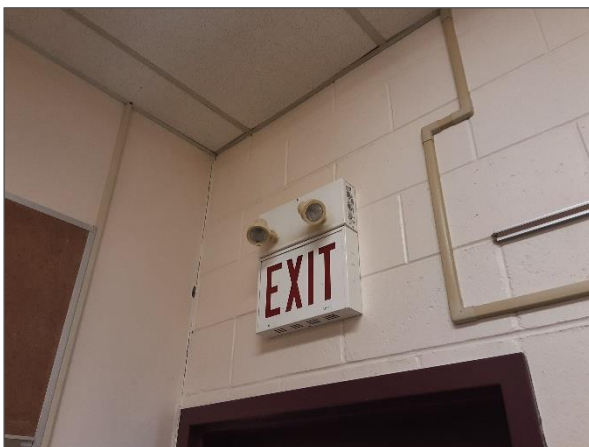
Lead-containing batteries in emergency lighting.

Lead-containing items should be recycled when taken out of service.

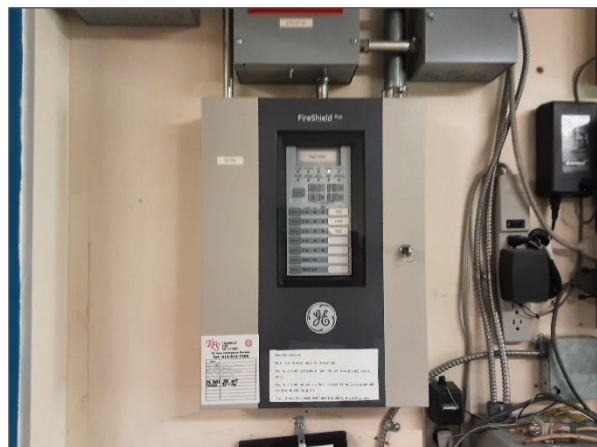
Lead-containing batteries in fire alarm control panel.

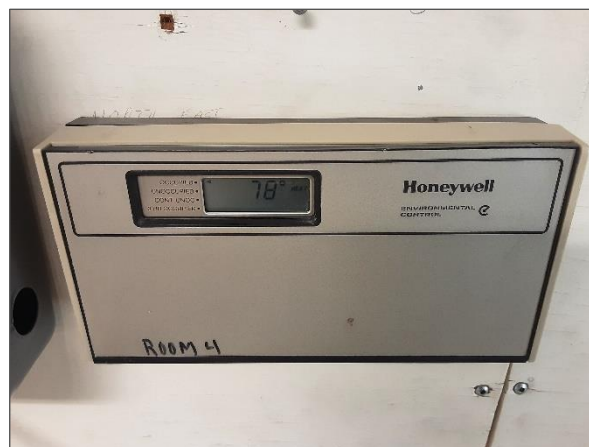
Thermostats inspected did not contain liquid mercury ampules.

Non-mercury digital thermostat.

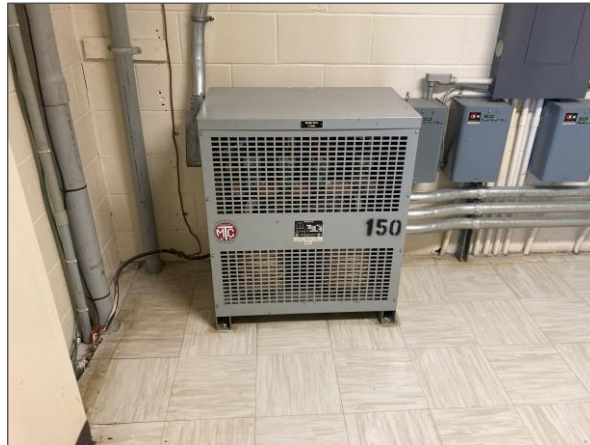
All transformers in the building are dry type transformers and do not contain PCB-containing dielectric fluids; however, may contain capacitors, which could not be assessed for PCBs as the equipment was in service.

Non-PCB dry type transformer.
